Release Note for AlliedWare Plus Software Version 5.5.3-0.x

AlliedWare Plus OPERATING SYSTEM

AMF Cloud
SBx81CFC960
SBx908 GEN2
x950 Series
x930 Series
x550 Series
x530 Series
x530L Series

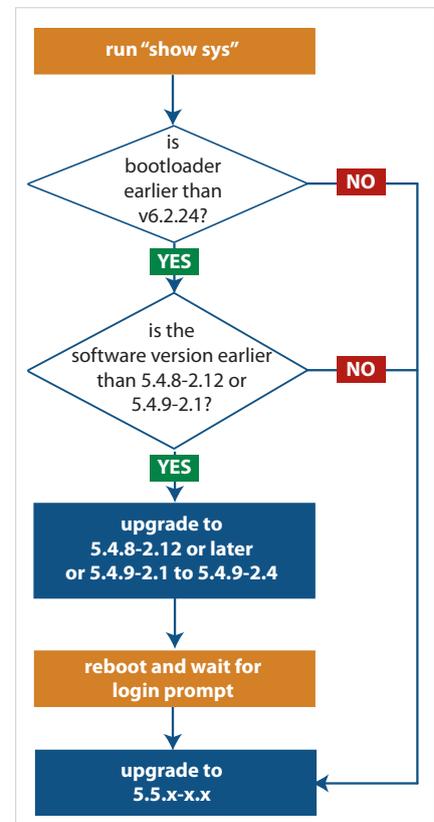
To see your bootloader and current software version, check the “Bootloader version” and “Software version” fields in the command:

```
awplus# show system
```

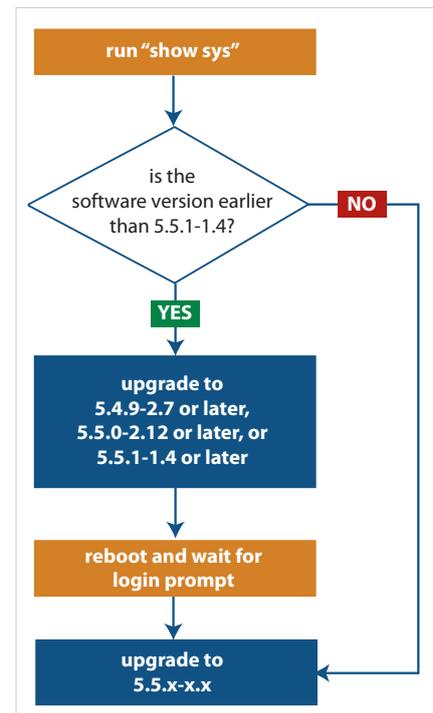
To see your current software version, check the “Software version” field in the command:

```
awplus# show system
```

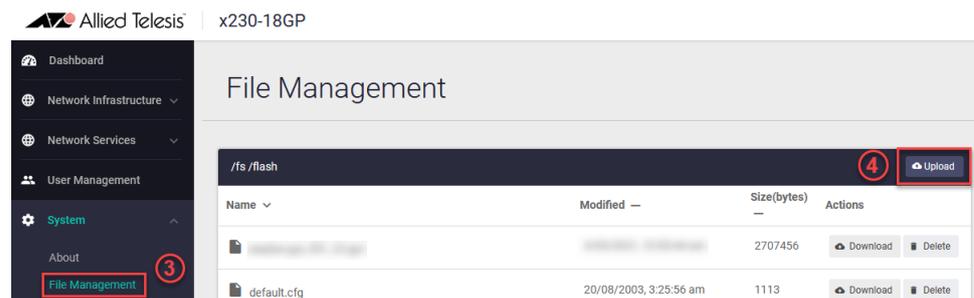
3. Go to **System > File Management**

4. Click **Upload**.
